**Stellwagen Family Farm
Exterior Restoration Recommendation Report**

Prepared for:
The Village of Orland Park

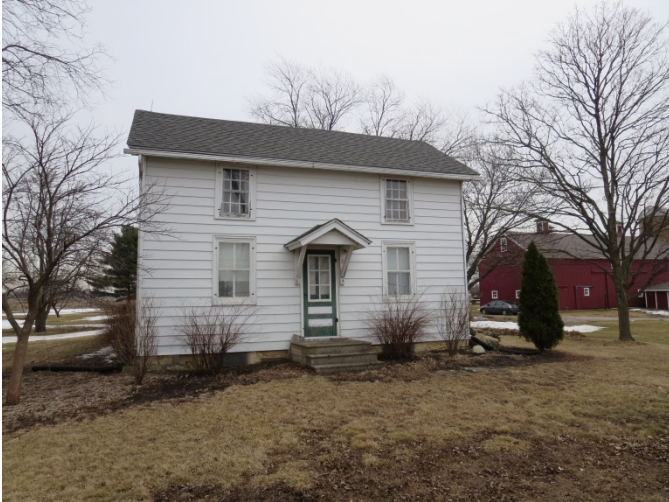
Photograph 1
Front (West) Facade.

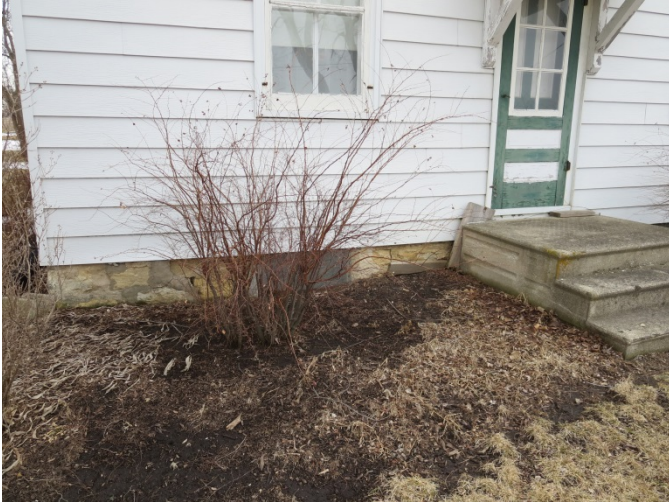
Photograph 3
Detail showing limestone foundation at west facade.

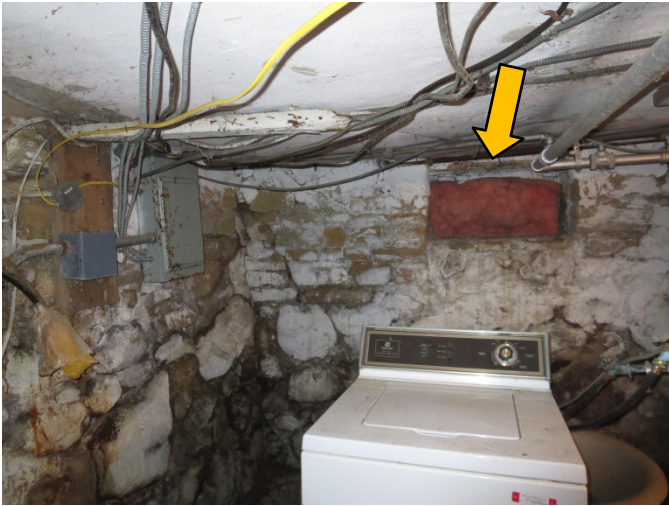
Photograph 4
Interior view of basement showing stone foundation wall. Note window blocked by insulation.

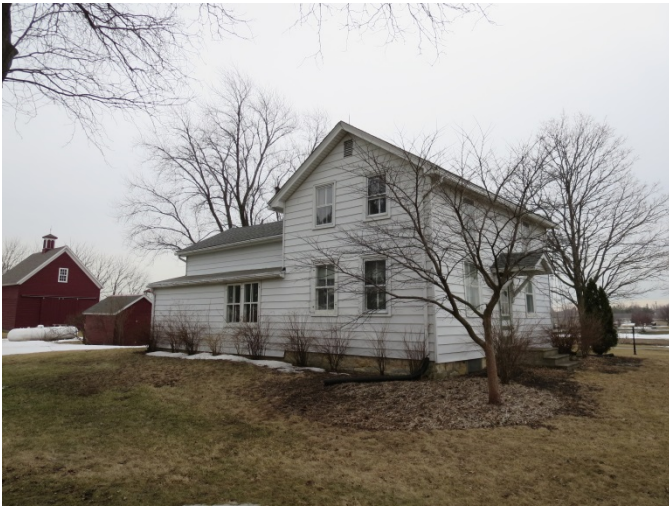
Photograph 5
Three quarter view showing north and west facades.

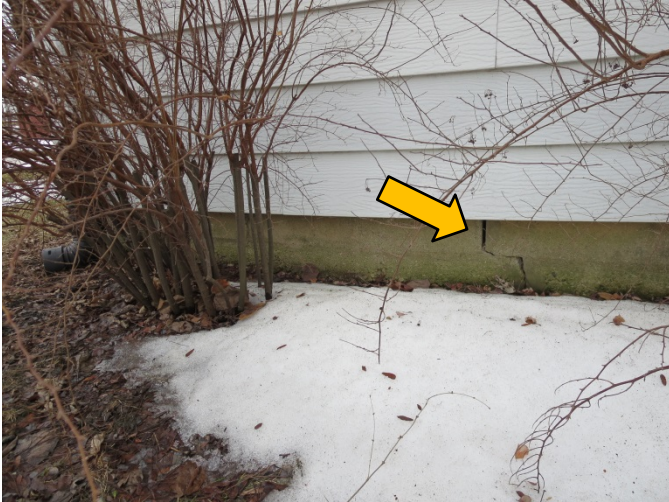
Photograph 6
Detail of concrete block foundation at east end of north facade. Note open mortar joints.

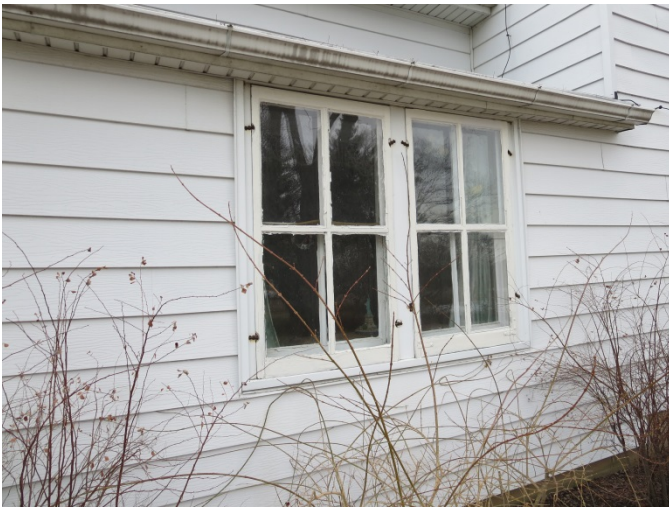
Photograph 7
Detail of first floor windows at north facade.

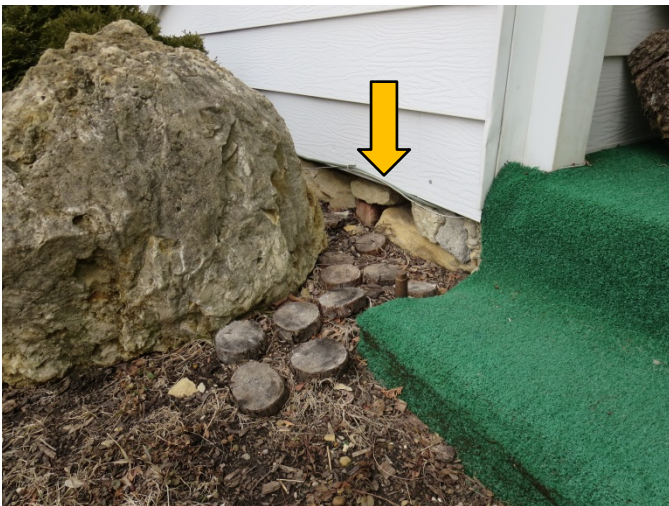
Photograph 19
Detail showing loss of mortar at stone foundation adjacent to side porch.

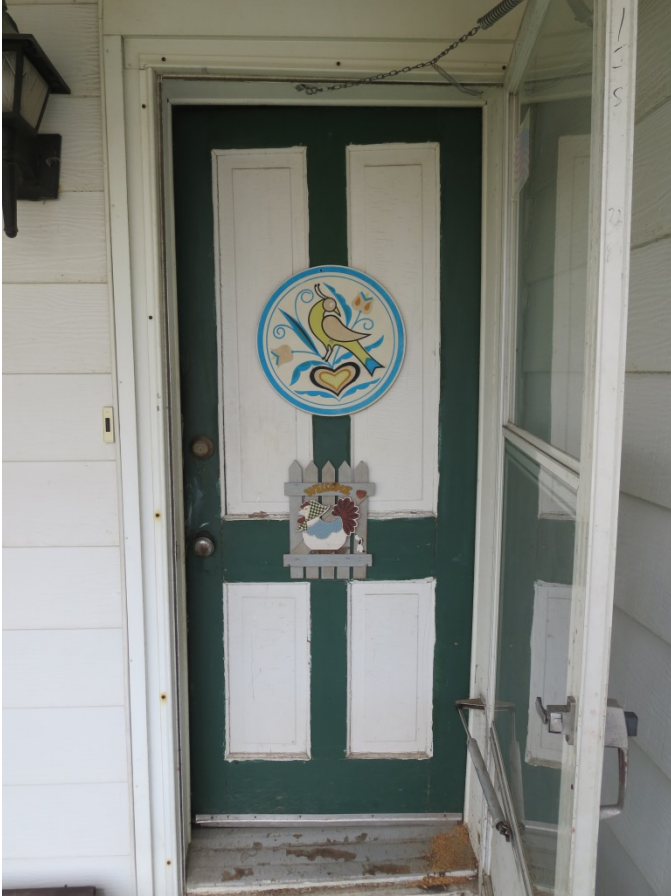
Photograph 20
Historic wood door at side (south) entrance.

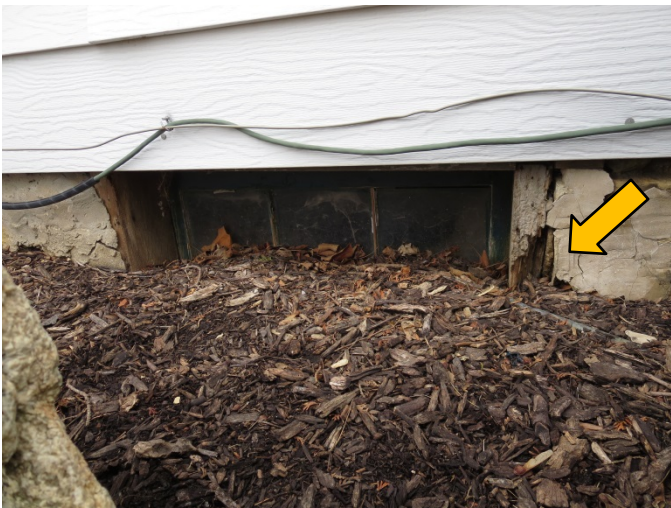
Photograph 21
Detail of basement window at south facade showing dirt mounded above the window sill. Note deterioration of exposed wood framing at window.
